FC EFI-1

# EMP FACILITIES INTERACTION

## 1 MARCH 1980

DEFENSE NUCLEAR AGENCY

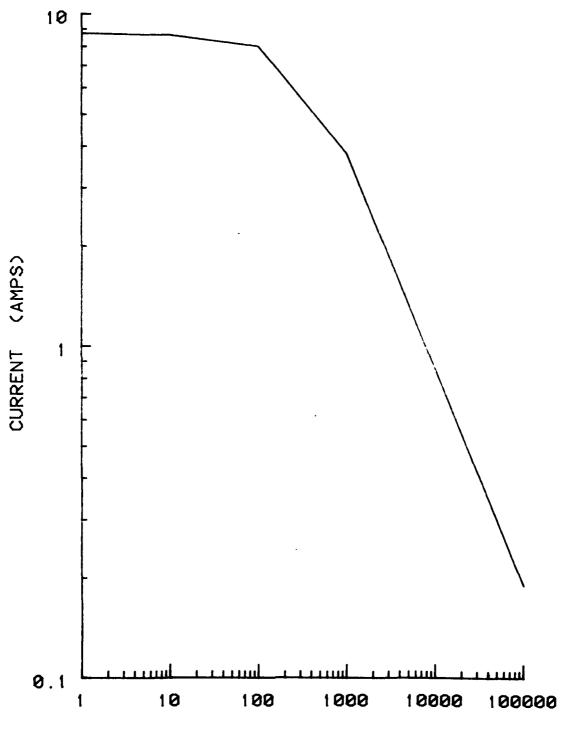
FIGURE 2-2

- f) R may represent the human body if personnel were to place themselves between the umbilical cable, etc and the missile.
  - g) Curve number 1 of Figure 2-5 and Figure 2-2 are worst case.

A3TK UMBILICAL CURRENT
(Missile and Zipper Tubing Grounded)

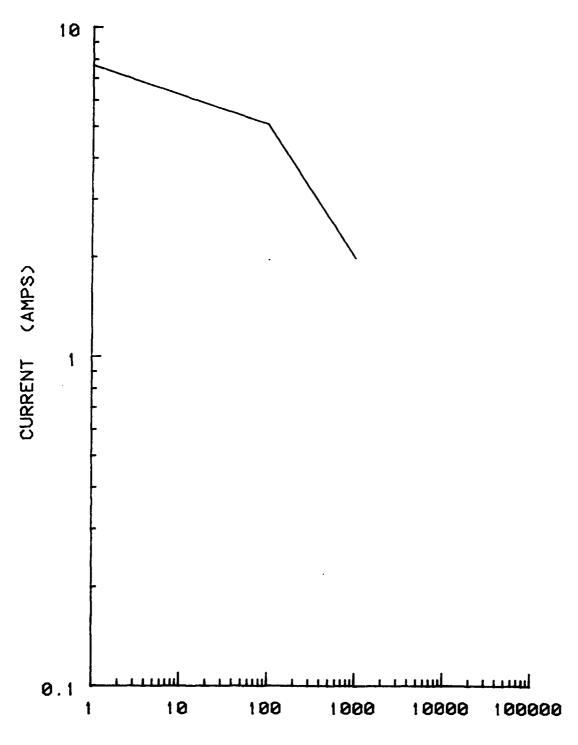
FIGURE 2-3

A3TK UMBILICAL CURRENT

(Missile Grounded: Zipper Tubing Ungrounded)

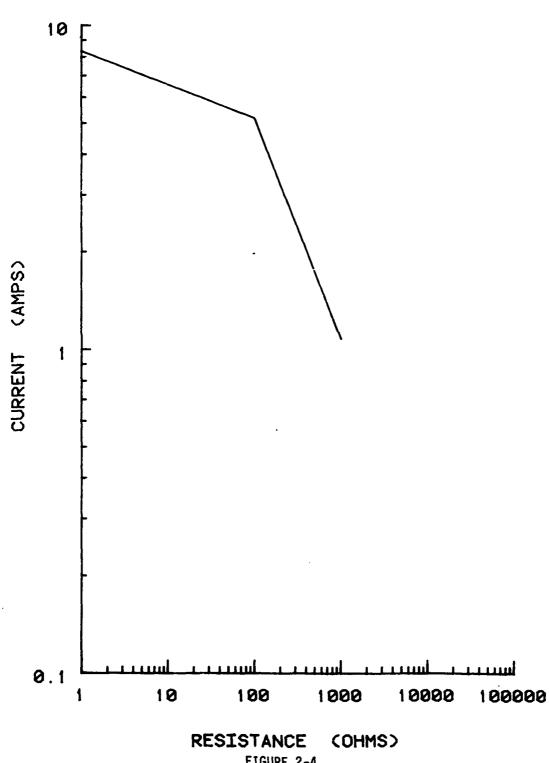
FIGURE 2-4

A3TK UMBILICAL CURRENT (Missile and Zipper Tubing Ungrounded)

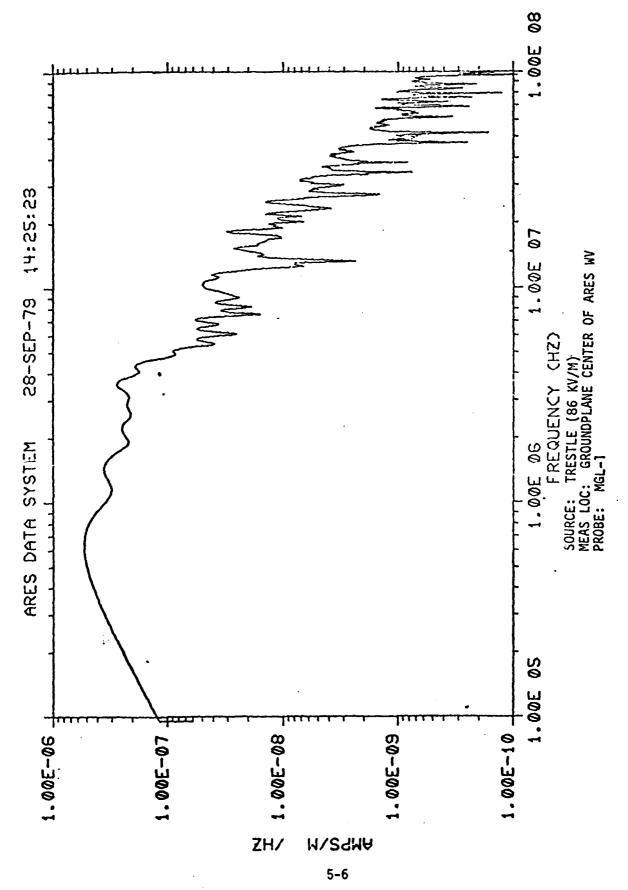
FIGURE 5-1

Figures 5-1 and 5-1-1 are the time and frequency domain plots of the TRESTLE waveform that is present in the center of the ARES working volume on the ground plane. The TRESTLE reference sensor measured an E field of 86 KV/m. The measurement was made using an MGL-1 B sensor. A peak field strength of 1 KV/m is observed. Obviously, there is some interaction from TRESTLE into ARES.

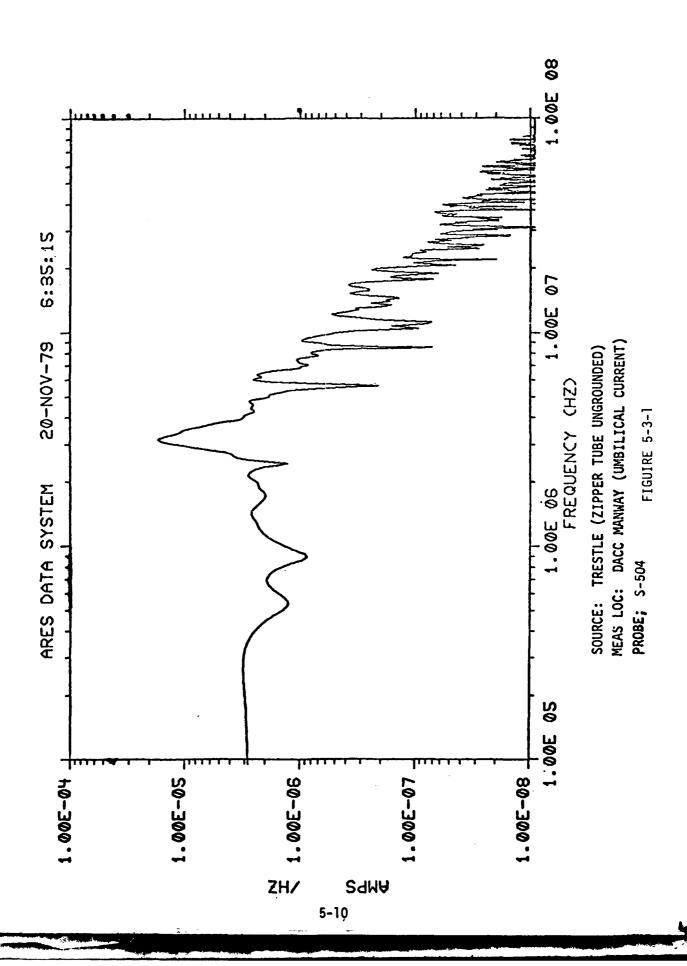
FTGURE 5-3

Figures 5-3, 5-3-1, 5-3-2, and 5-3-3 are time and frequency domain plots of measurements made to determine the effectiveness of shielding the missile umbilical cables and then grounding the shielding to the ARES ground plane. These measurements were made using a Singer 93686-4m current sensor. The measurements were made by inserting the umbilical and zipper tubing through the sensor and measuring the current flow

first with the zipper tubing ungrounded and second with the zipper tubing attached to the ARES ground plane. The TRESTLE pulsers were charged to 3.5 MV each during this measurement. A marked decrease in current amplitude was observed after the zipper tubing was grounded. This demonstrates an extremely effective method of shunting unwanted currents away from ARES test objects. Two dominant frequencies of 3.0 and 10.0 MHz are observed in figures 5-3-1 and 5-3-3. The corresponding wavelengths are 100m and 29.7m. These wavelengths approximate closely four times the length of the umbilical cable when it is ungrounded and then grounded. The conclusion drawn from this information is that the umbilical cable is acting as a quarter wavelength antenna and coupling energy from sources external to ARES into the ARES test object and equipment and that this effect can be minimized by using an effective shielding technique.

- a) Capacitor filters have been installed at power outlets inside of the DACC.
- b) Zipper tubing has been installed so as to shield the umbilical cables extended from the unprotected DACC into the working volume.
- c) A portable screen room has been installed in the DACC and sensitive equipments have been placed inside.

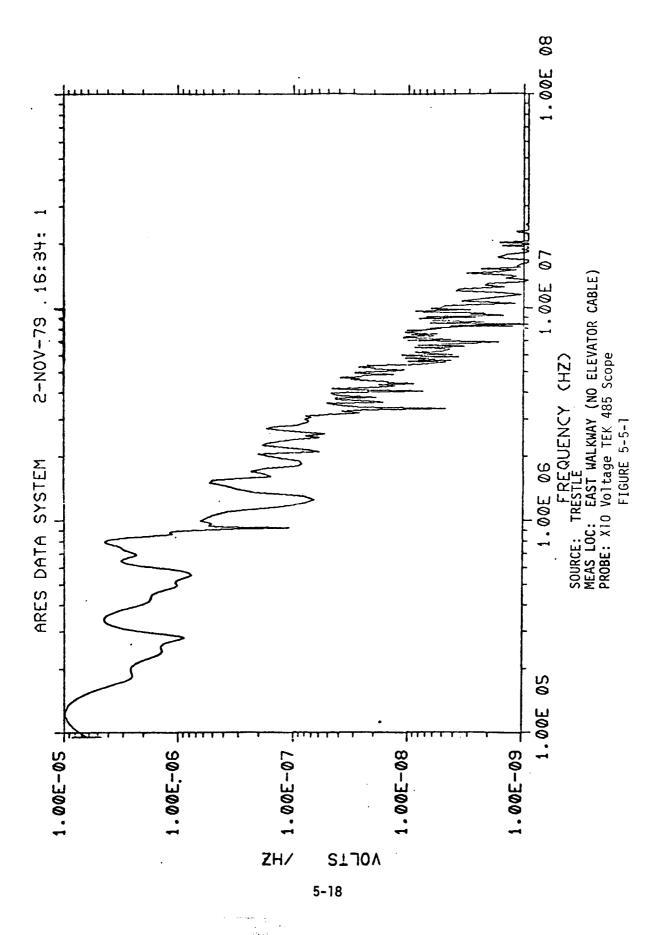
FIGURE 5-5

Figures 5-5, 5-5-1, 5-5-2, and 5-5-3 demonstrate that power cords of other types of cables that extend into the ARES working volume during TRESTLE pulser discharge furnish another point of entry of EMI into the ARES DACC and test support equipment. These cords are not present during ARES pulser discharge but are essential for test object reconfiguration and may be present during pulser operations at other facilities. These cords could cause equipment upsets by passing spurious signals through the power lines or by reradiation of EMI into the DACC. Dominant frequencies approximate four times the length of the heater and drop cords. This data set was taken with 1 trestle pulser charge to 4 MV.

- Potential ARES users develop a conscientious program of configuration control over inadvertant antennas.

- Potential ARES users place added protection devices at the input to equipment identified as sensitive to the EMP levels described in this report.
- Potential ARES users provide shielding for all inadvertent antennas in or near the ARES working volume.
- FCDNA coordinate quiet times as necessary to eliminate equipment problems described in section four of this report.
